### **City of Charlevoix Historic District Commission Regular Meeting**

**Friday, December 27, 2024 - 11:00 AM**

**TOOHEY PLANT SELECTIONS**  
304 PARK AVE., CHARLEVOIX, MICHIGAN 49720

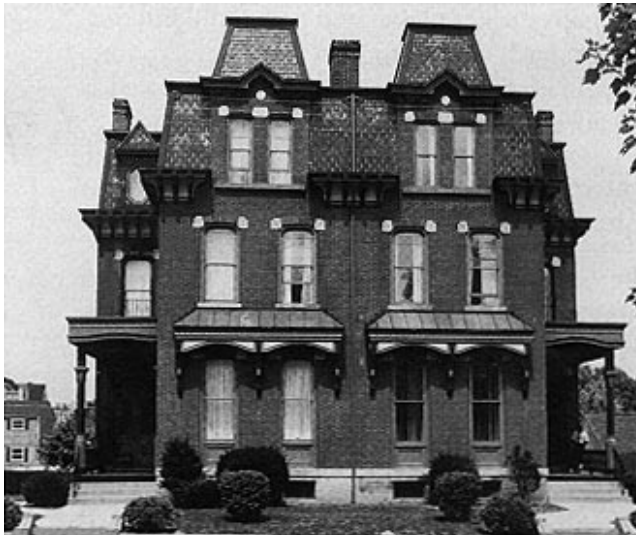
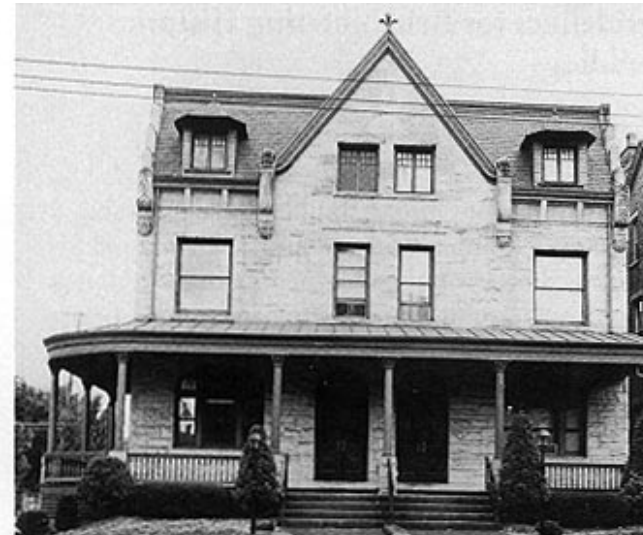
*Originally built as single-family, semi-detached duplexes, these houses were rehabilitated for a new use as rental apartments. While some alteration to non-significant interior features and spaces was necessary in each one, the exteriors were essentially preserved. Photos: Mistick, Inc.*

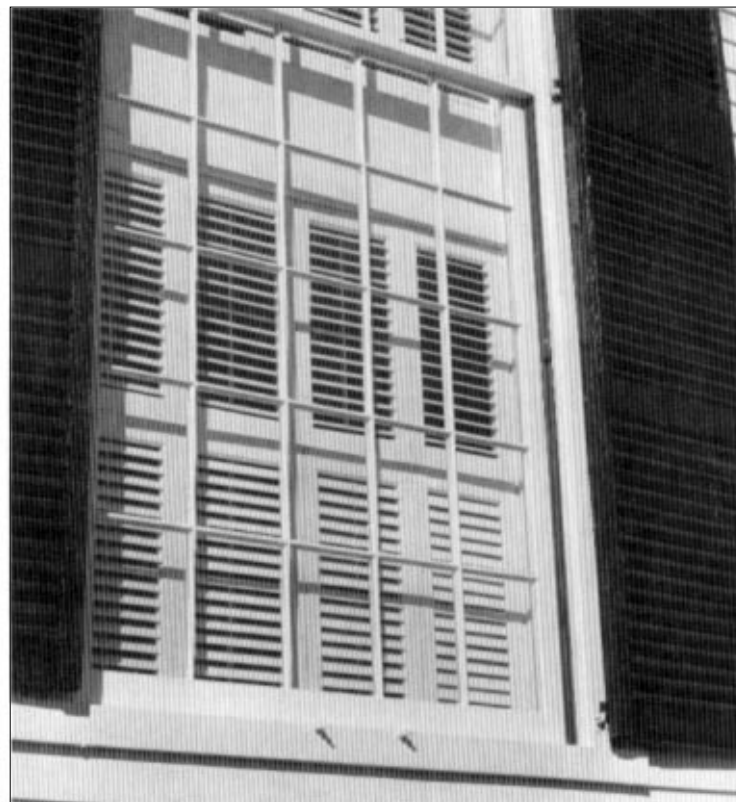
*According to the Standards for Rehabilitation, existing historic materials should be protected, maintained and repaired. In an exemplary project, the windows and shutters of this historic residence were carefully preserved.*

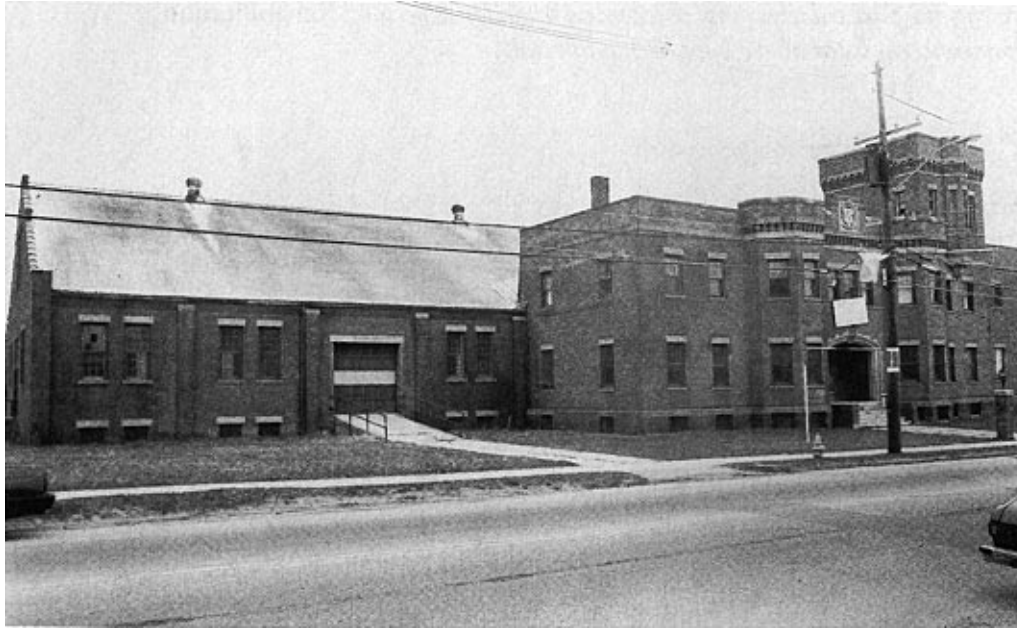
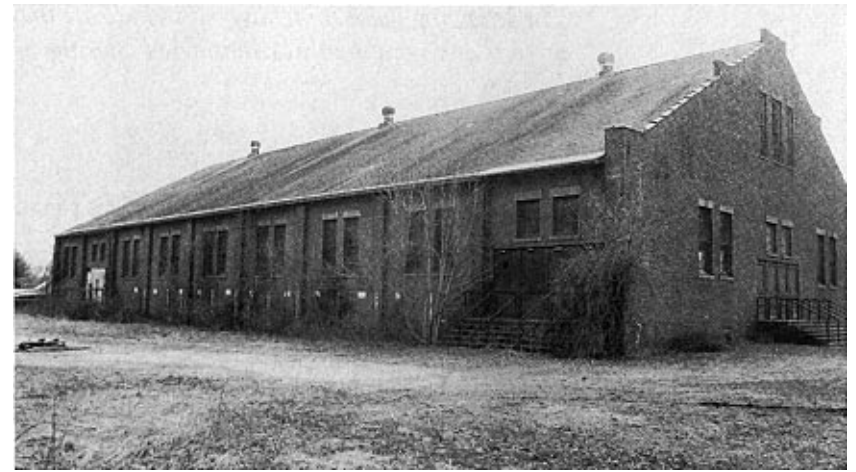
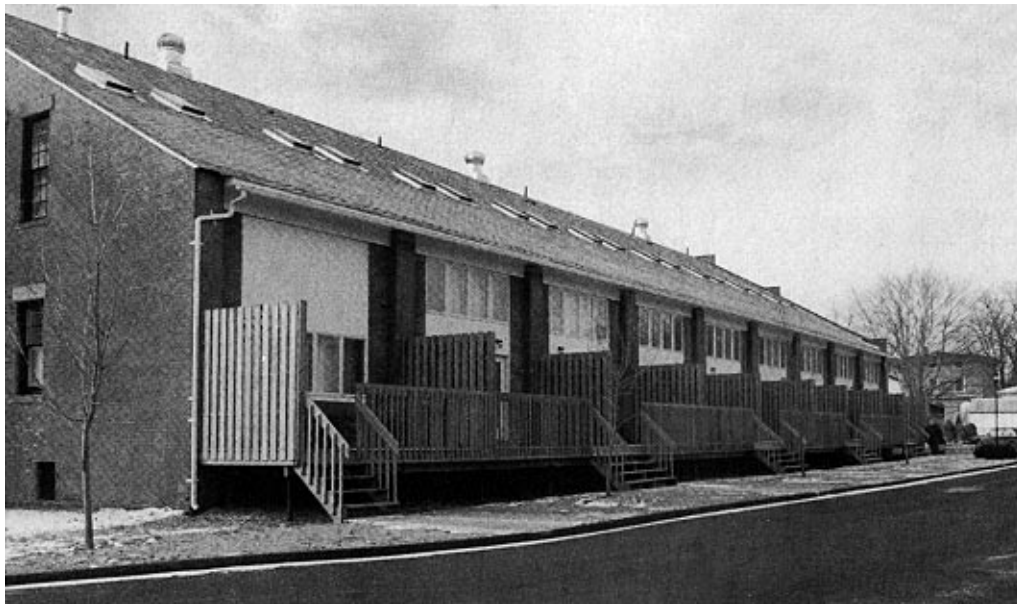
*(a) An armory complex was rehabilitated for rental housing. (b) This view of the rear elevation shows the paired, nine-over-nine wood sash windows and high sills that characterized the building. (c) After inappropriate rehabilitation work, the same rear elevation is shown with new skylights added to the roof, prefabricated panels filling the former brick areas, and new wood decks and privacy fences. Because the work changed the historic character, the project did not meet the Standards.*

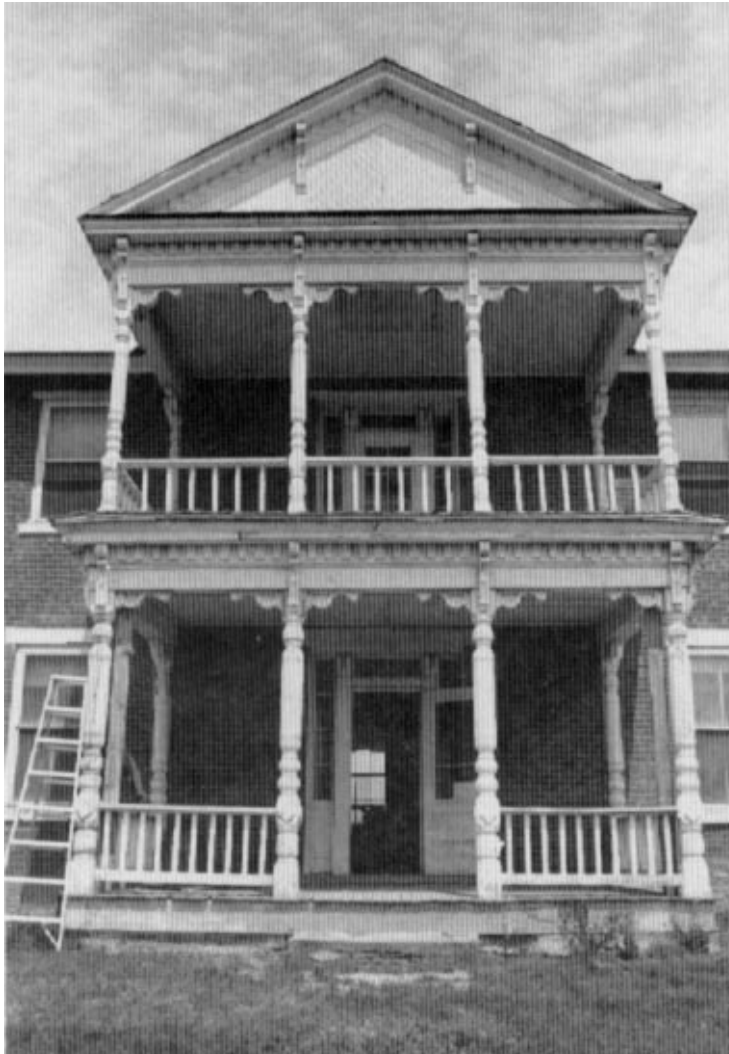
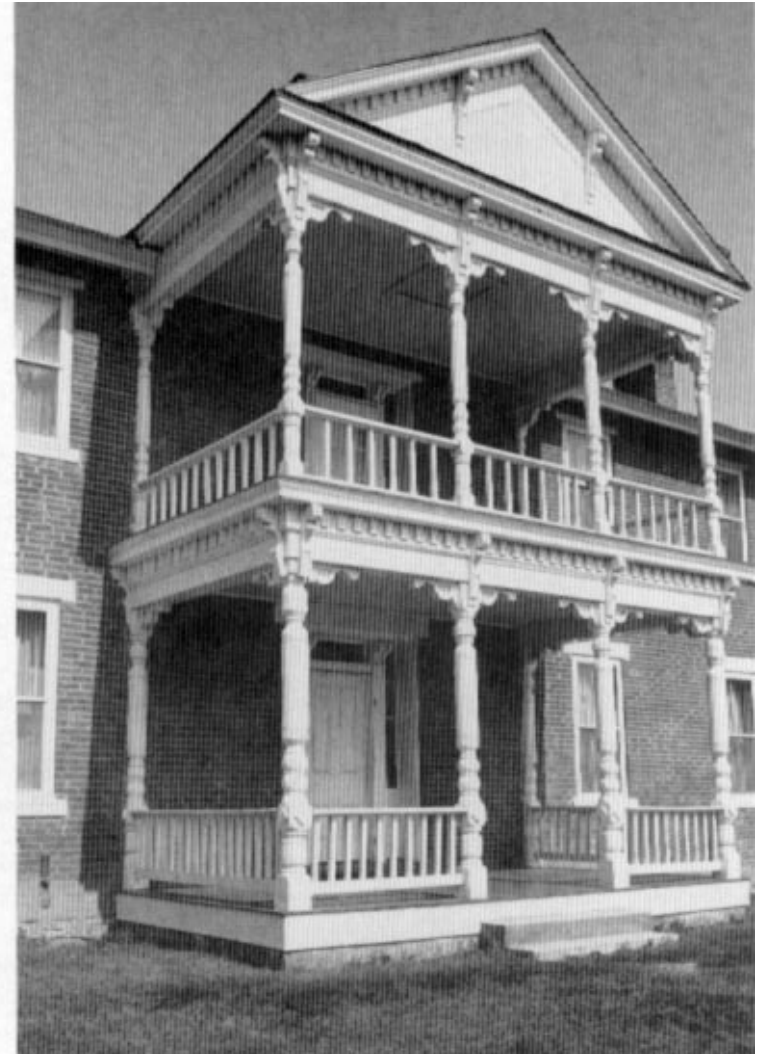
*In Rehabilitation, deteriorated features should be repaired, whenever possible, and replaced when the severity of the damage makes it necessary. Here, a two-story porch is seen prior to treatment (left). The floor boards are rotted out and the columns are in a state of collapse, supported only by crude, temporary shafts. Other components are in varying stages of decay. Appropriate work on the historic porch (right) included repairs to the porch rails; and total replacement of the extensively deteriorated columns and floor boards. Some dismantling of the porch was necessary.*

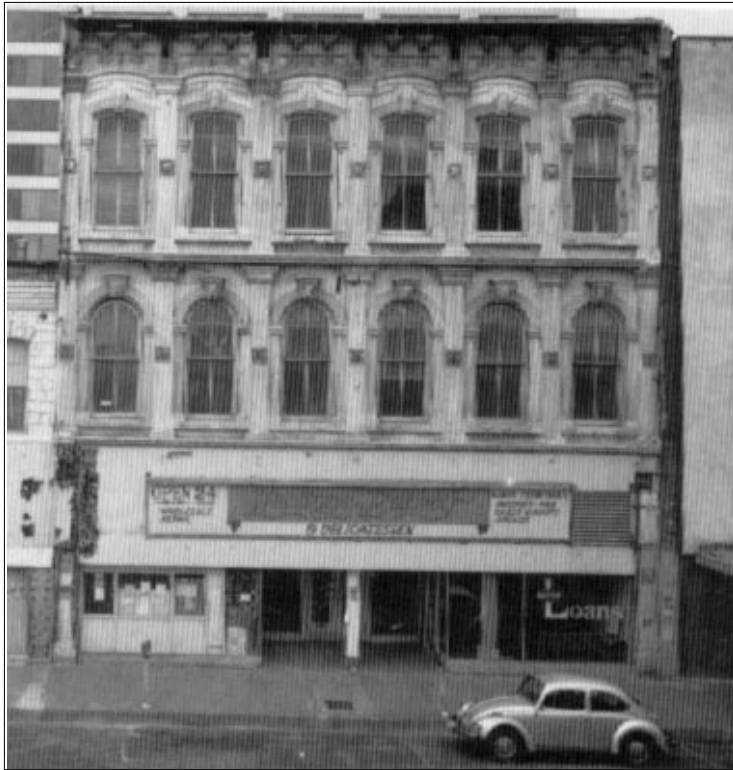
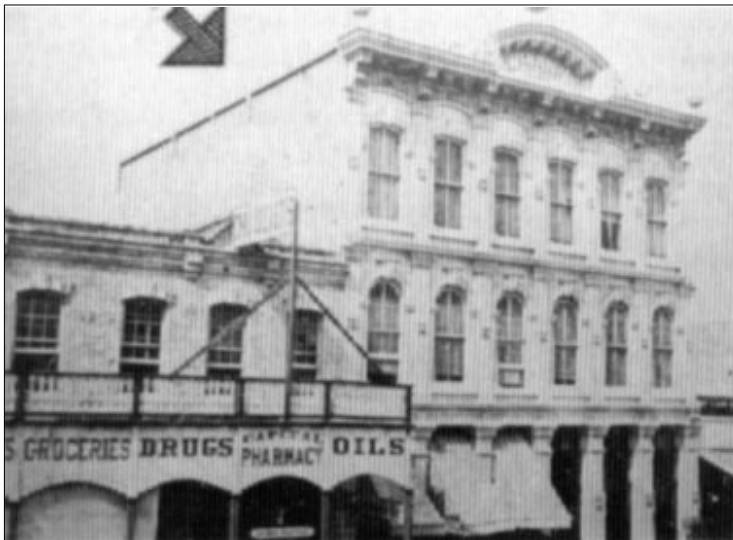
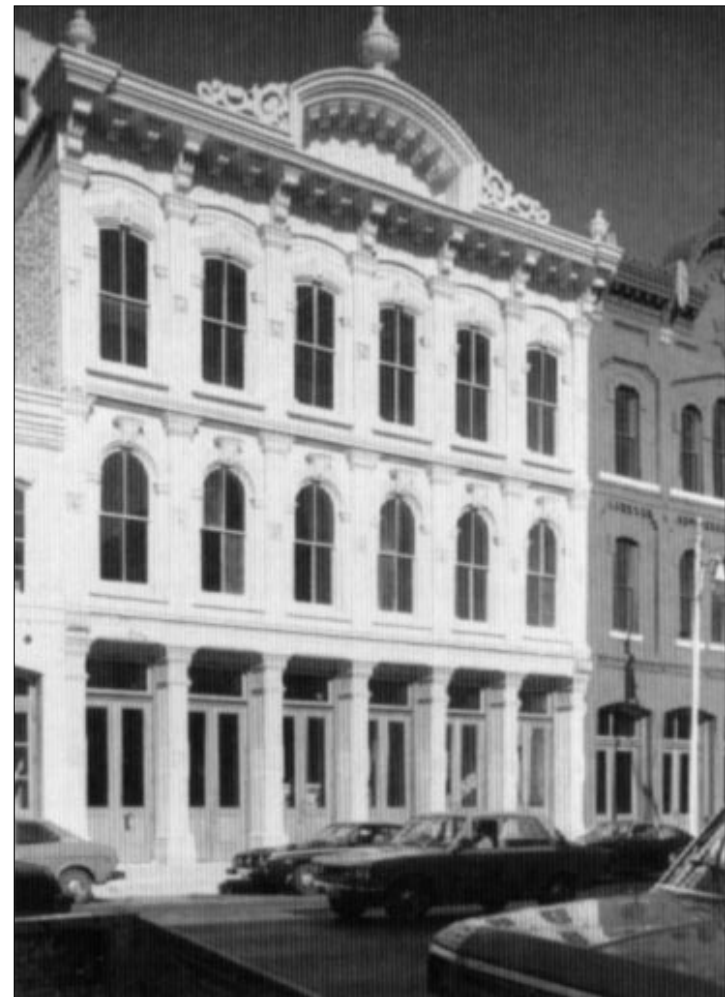
*In the treatment, Rehabilitation, one option for replacing missing historic features is to use pictorial documentation and/or physical evidence to re-create the historic feature. (a) In this example, the ornamental cornice of an 1866 limestone building was missing; and the ground level storefront had been extensively altered. (b) and (c) Based on the availability of photographic and other documentation, the owners were able to accurately restore the cornice and storefront to their historic configuration. A substitute material, fiberglass, was used to fabricate the missing pressed metal cornice, an acceptable alternative in this project. All work met the Standards.*

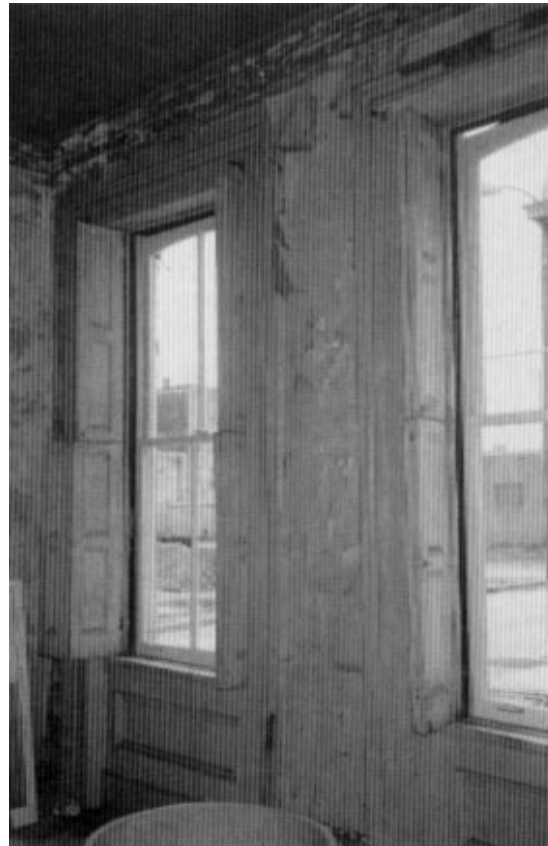
*a**Not Recommended*

Rehabilitating historic dwelling units often includes some level of lead-paint hazard abatement. Whenever lead-based paint begins to peel, chip, craze, or otherwise comes loose (*a*), it should be removed in a manner that protects the worker as well as the immediate environment. In this example (*b*), the deteriorating lead-paint was removed throughout the apartment building and a compatible primer and finish paint applied.

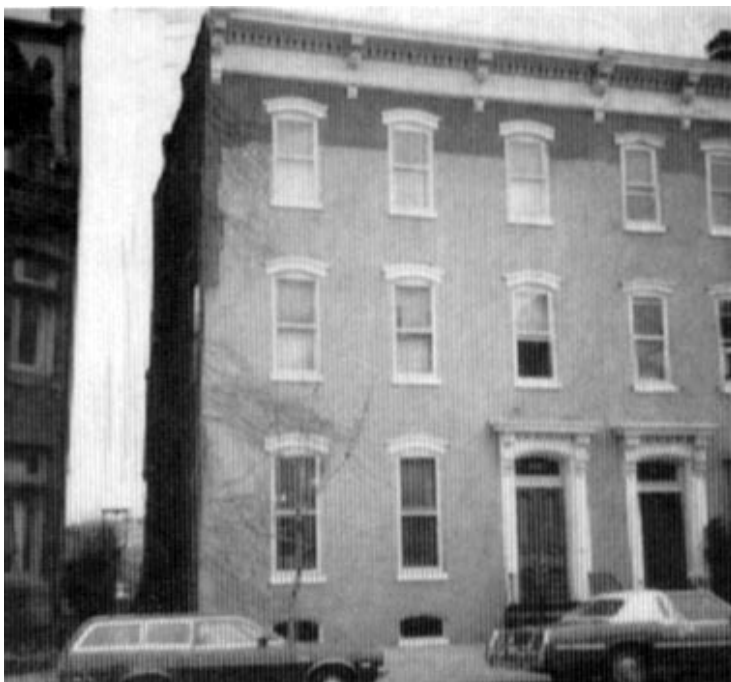
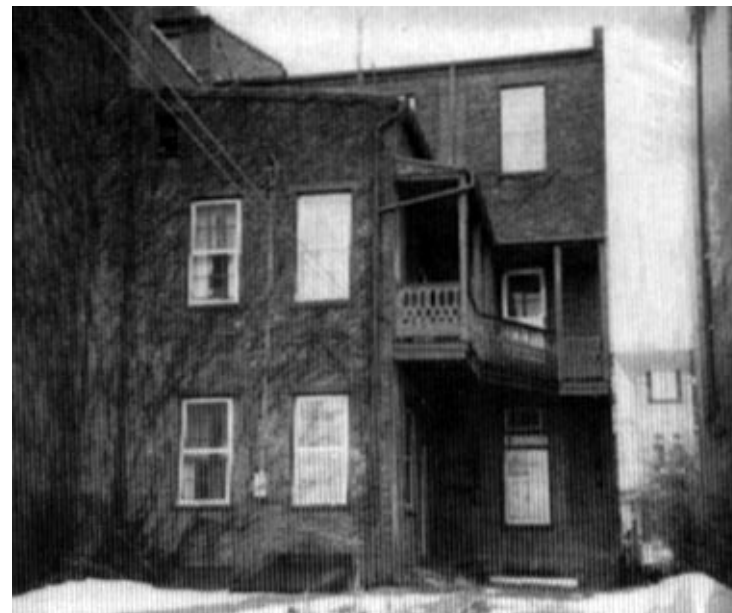
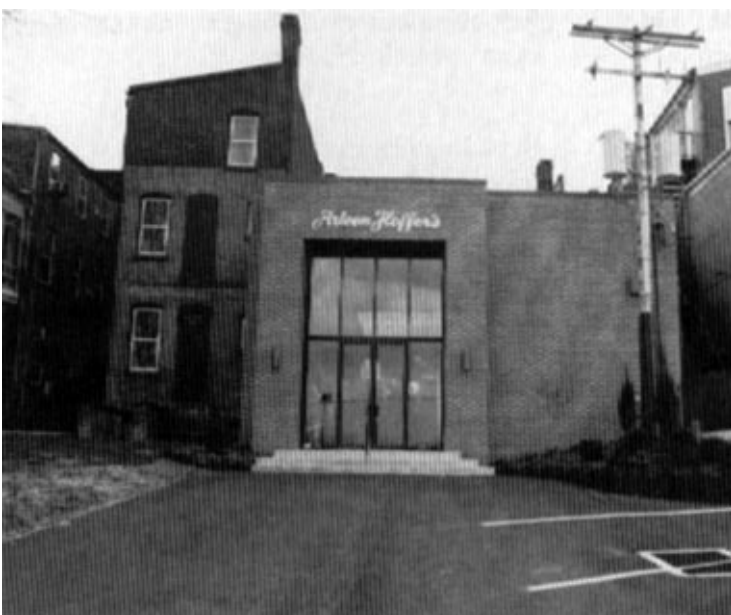
*If a rear elevation of a historic building is distinctive and highly visible in the neighborhood, altering it may not meet the Standards. (a and b) This 3-story brick rowhouse featured a second story gallery and brick kitchen wing characteristic of other residences in the district which backed onto a connecting roadway. (c) In the rehabilitation, the wing and gallery were demolished and a large addition constructed that severely impacted the building's historic form and character.*

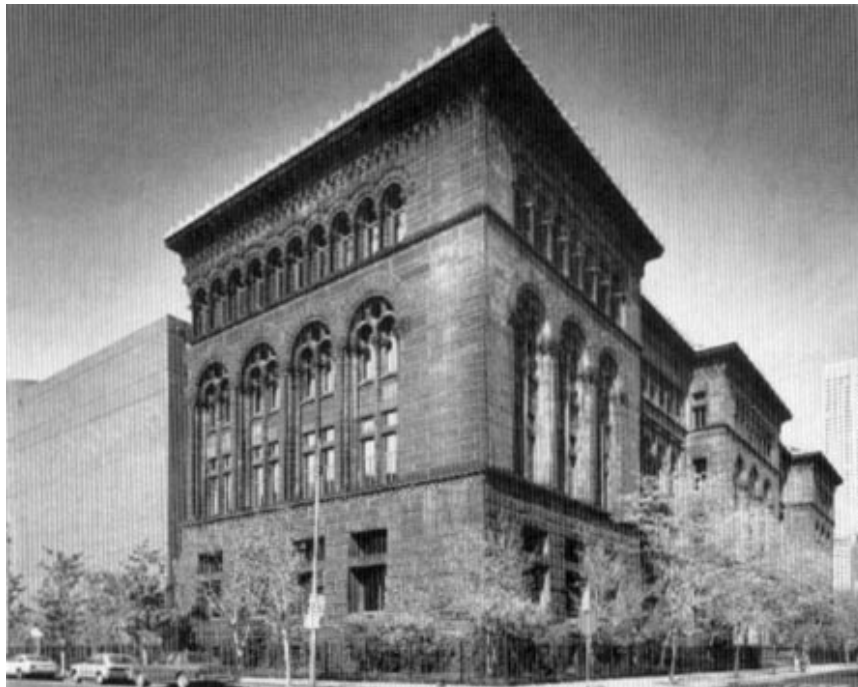
*Rehabilitation, like Preservation, acknowledges a building's change over time; the retention and repair of existing historic materials and features is thus always recommended. However, unlike Preservation, the dual goal of Rehabilitation is to—respectfully—add to or alter a building in order to meet new use requirements. This downtown Chicago library was expanded in 1981 when additional space was required with light and humidity control for the rare book collection. The compatible 10-story wing was linked to the historic block on side and rear elevations. Its simple design is compatible with the historic form, features, and detailing; old and new are clearly differentiated. Photo: Dave Clifton.*

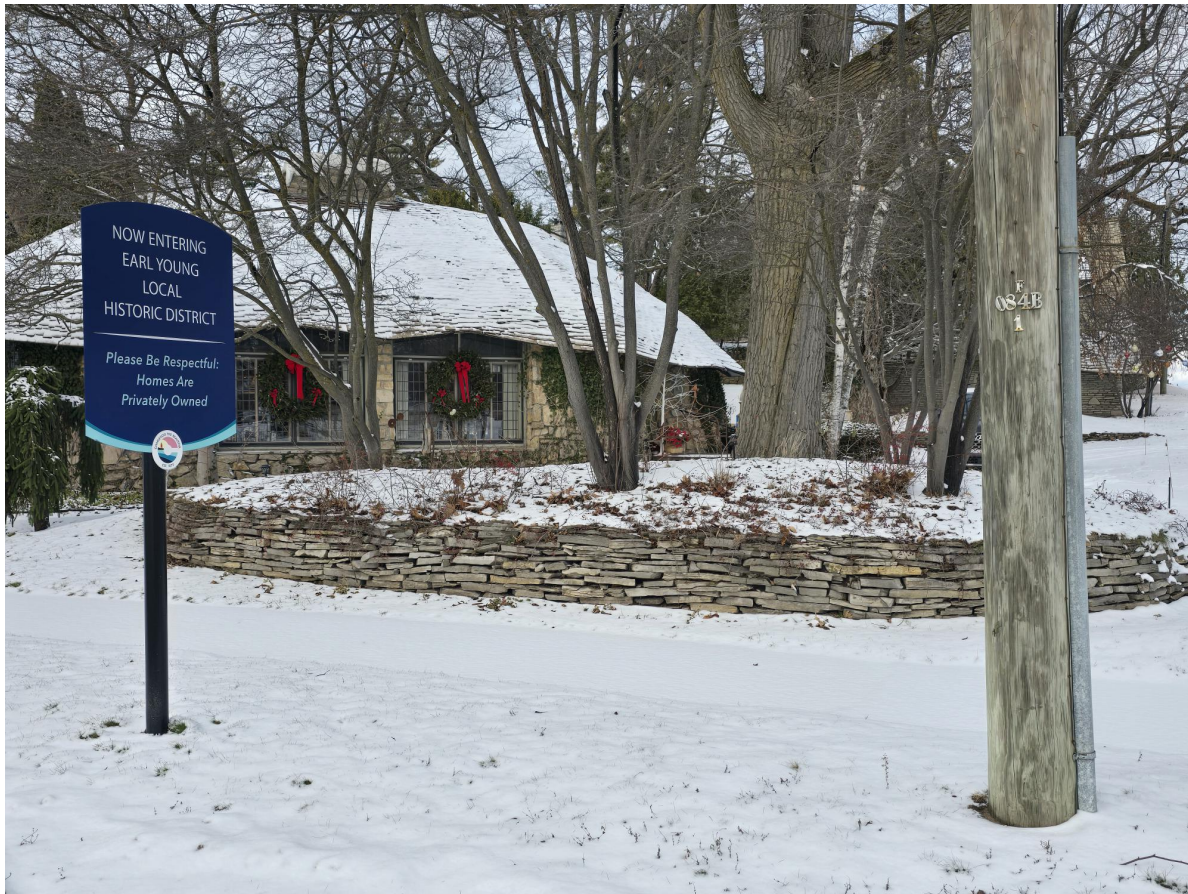
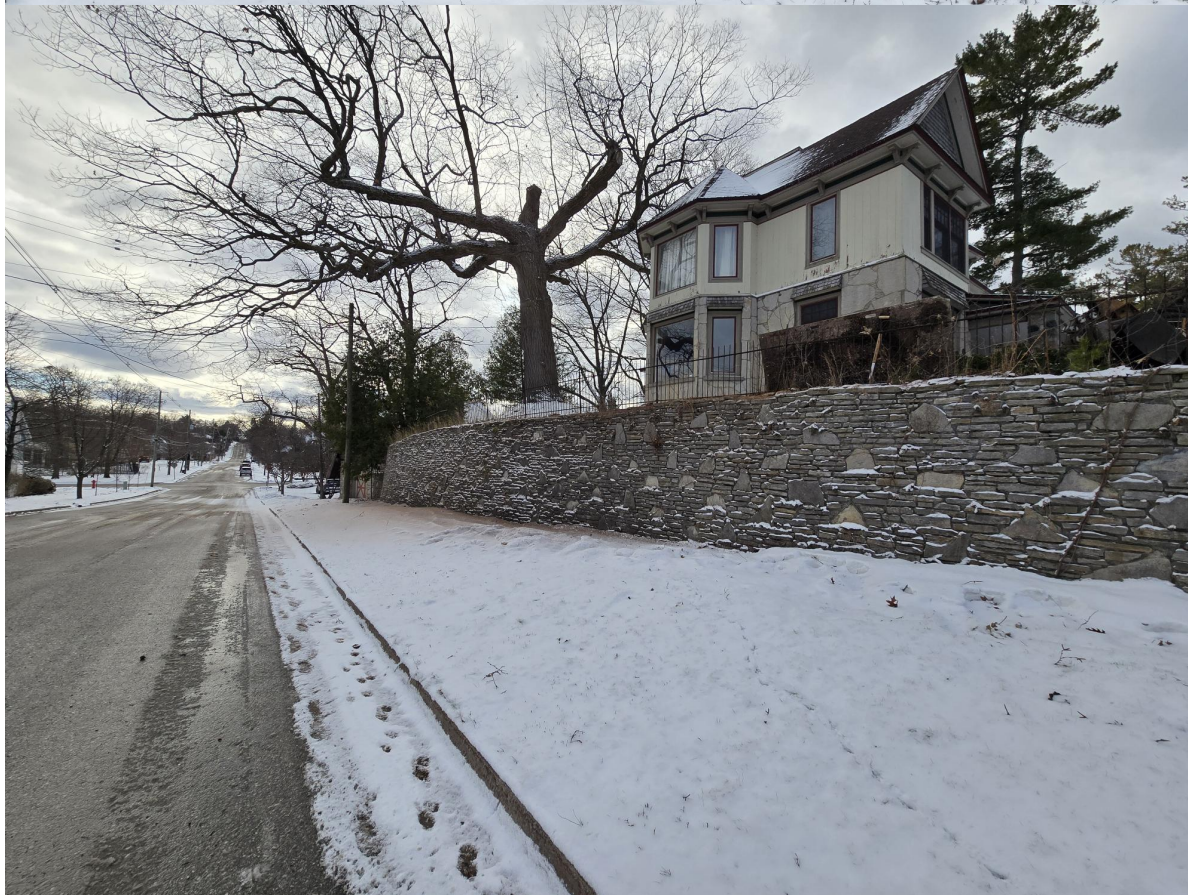
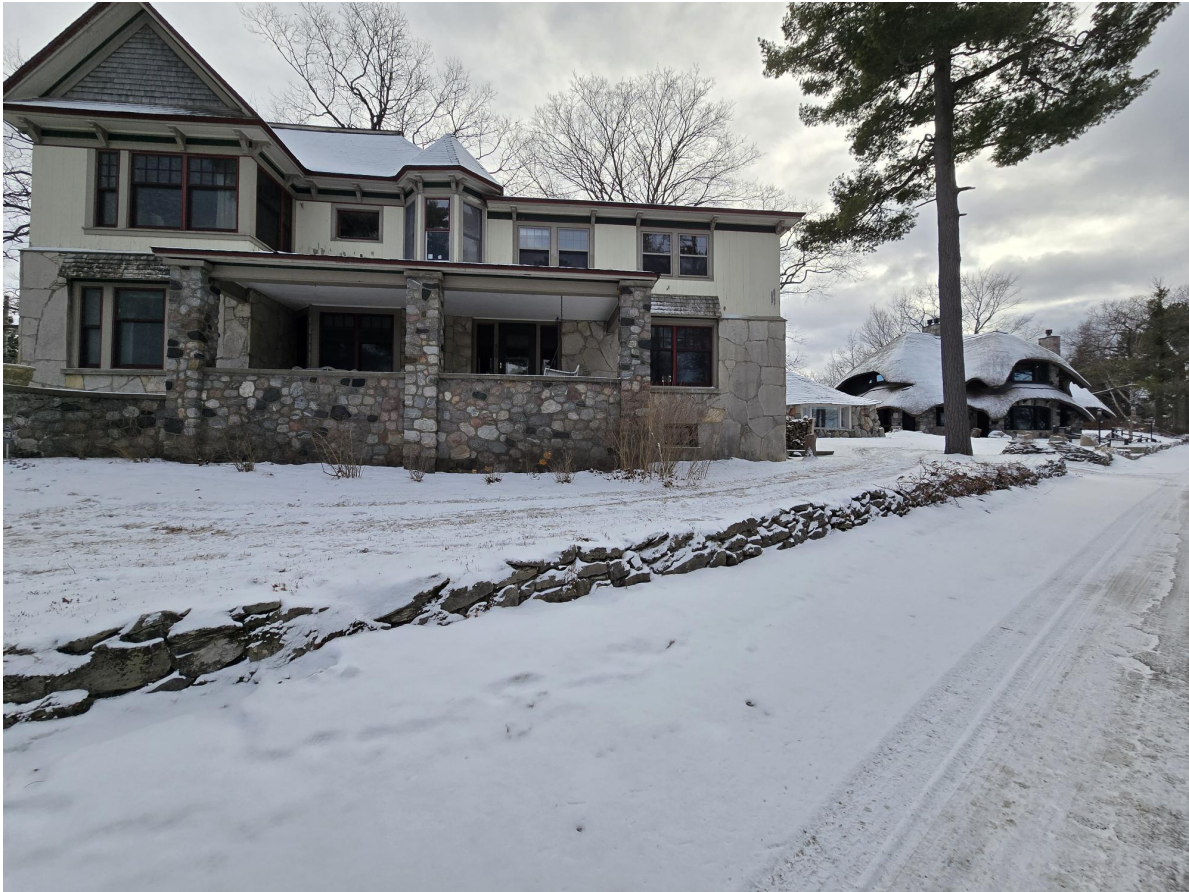
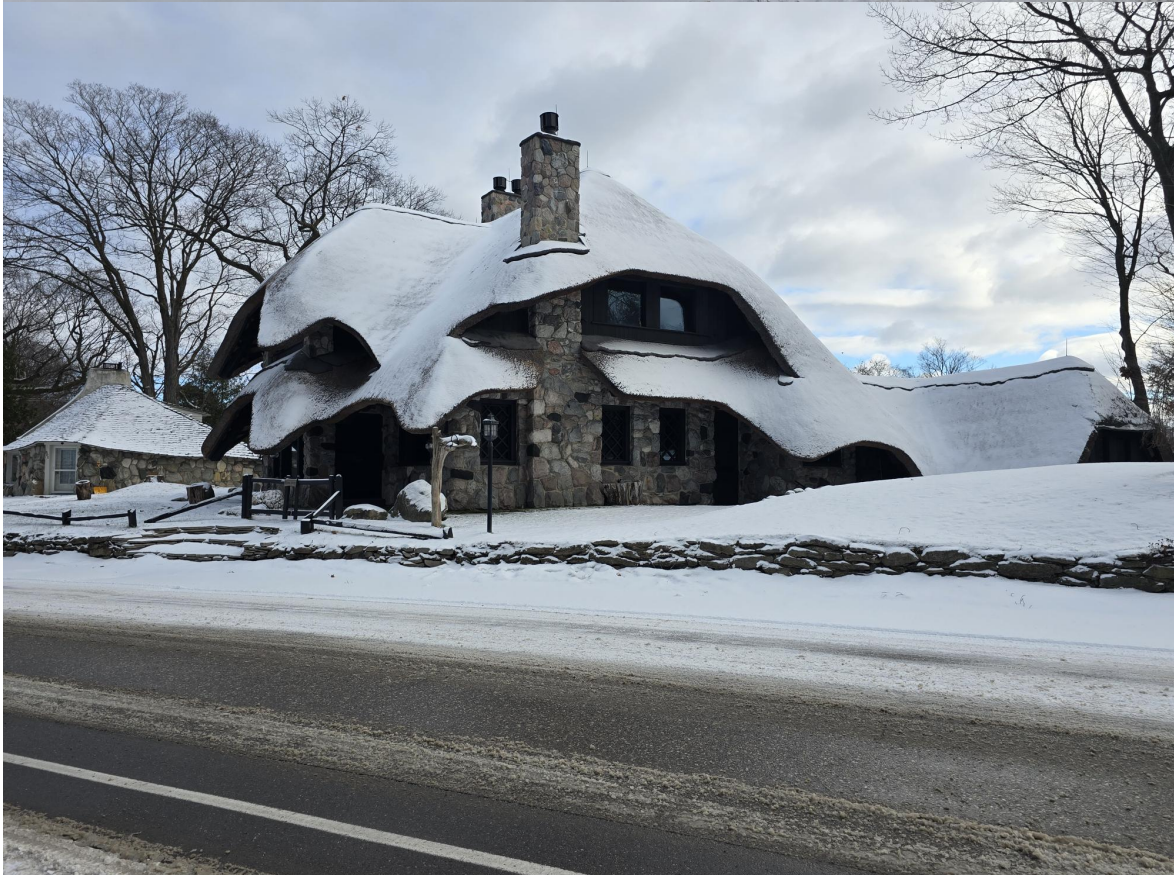
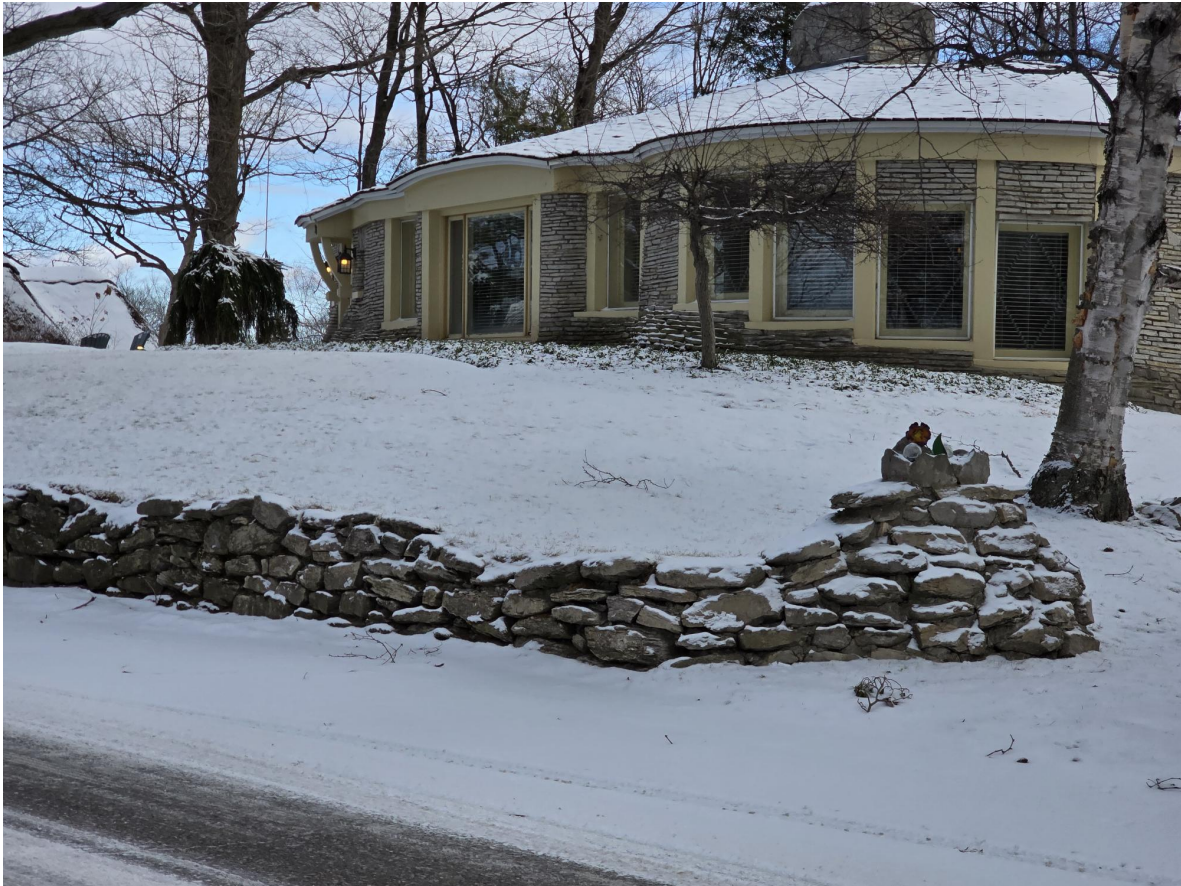
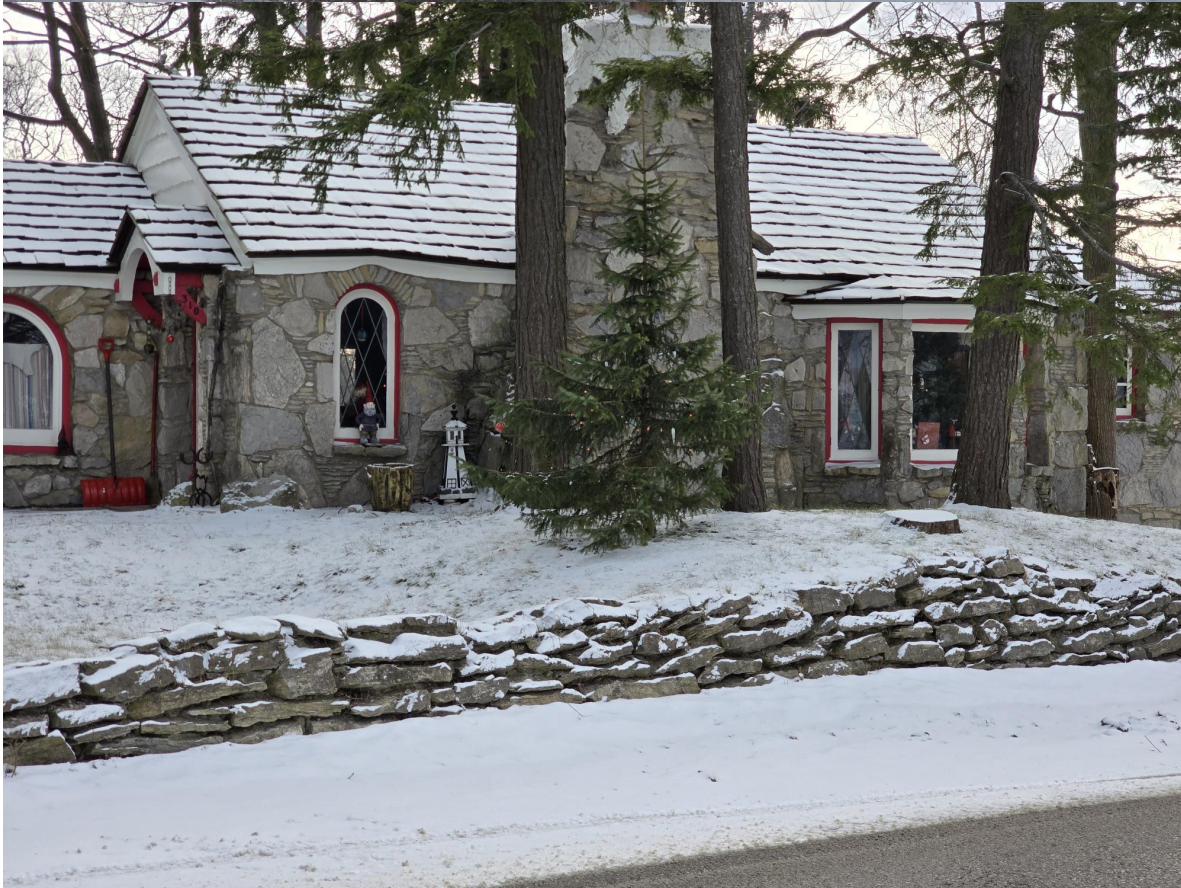
Following are recent pictures of existing conditions of exterior walls and fences in the Earl Young Historical District
